**US Army Corps
of Engineers®**
Portland District

September 2003 Progress Report: Fern Ridge Embankment

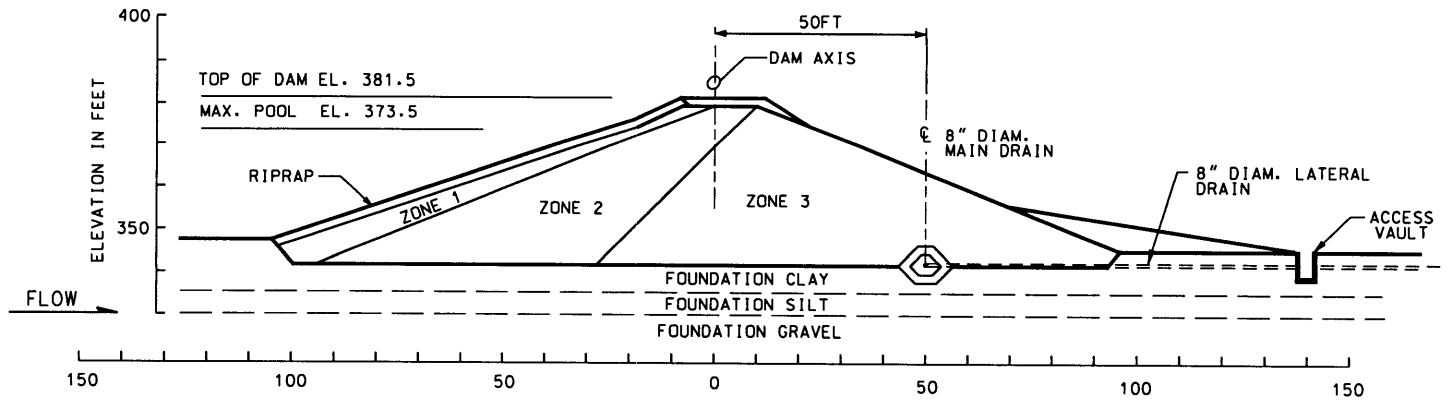
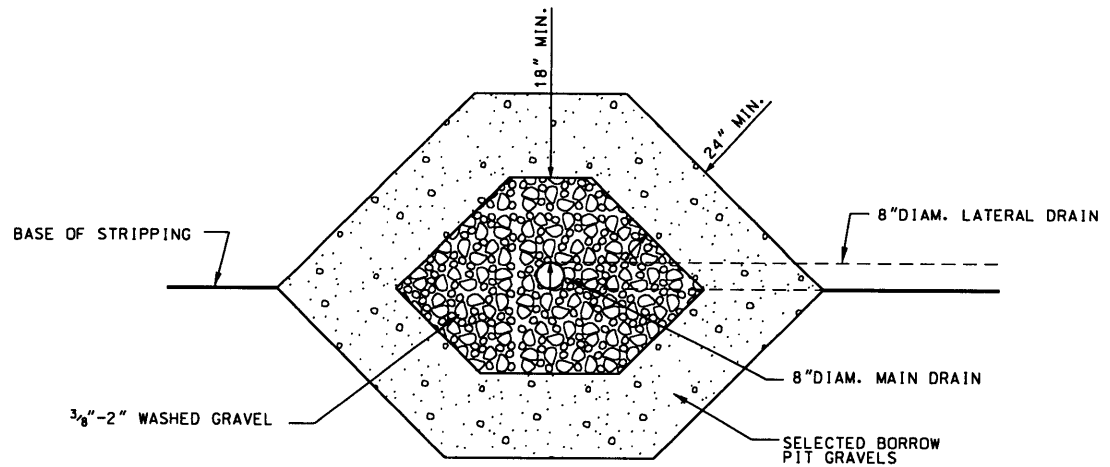
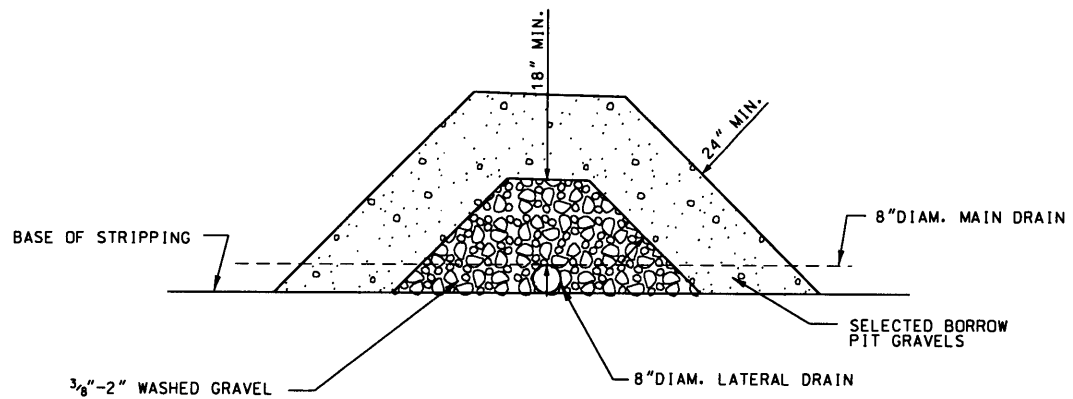
Figure 1.02-1 Typical Dam Cross Section and Details of Main and Lateral Drains

b. General Description of Embankment, Foundation, and Drainage System. Figure 1.02-1 shows the embankment section at station 49 + 40. A layer of riprap two feet thick was placed on the upstream slope. Zone 1 is composed of pervious gravels. Zone 2 is the impervious zone. It is composed of alluvial silty clay with sand and gravel, with layers of predominantly granular soil. Zone 3 was to be constructed of random material. The specification stated, “In general, this material shall be placed so that the more impervious materials are placed next to Zone 2 and graded to pervious towards the downstream edge of the section.” Laboratory tests performed on Zone 3 material in 1980 showed the material to have the same properties as those of Zone 2. A disposal zone sits at the downstream toe of the embankment and appears to be consistent with Zone 3 material properties.

Seepage through the earthen embankment is controlled and collected by the corrugated metal pipe drainage system. The drainage system has a longitudinal main drain running the length of the dam that is offset 50 feet downstream of the dam centerline. Lateral drains are located roughly every 500 feet along the length of the dam. Figure 1.02-2 shows the drainage system in plan view. Figure 1.02-1 shows a section of the main drain and a section of a lateral drain. The main drain is an 8 inch, perforated, corrugated metal pipe with bituminous coating. The filter around the pipe has two zones: $\frac{3}{8}$ inch to 2 inch washed gravel surrounding the pipe and selected borrow pit gravels surrounding the washed gravel. The lateral drains are similar to the main drain except the

lateral drains are not perforated and the filter only surrounds the top half of the lateral pipes; the bottom portion of the lateral pipe sits directly on the foundation.

The drainage system is 60 years old. The service life of corrugated metal pipe is approximately 25 to 30 years; the service life of bituminous coatings is usually only 1 or 2 years (Ohio Department of Natural Resources, 2003).

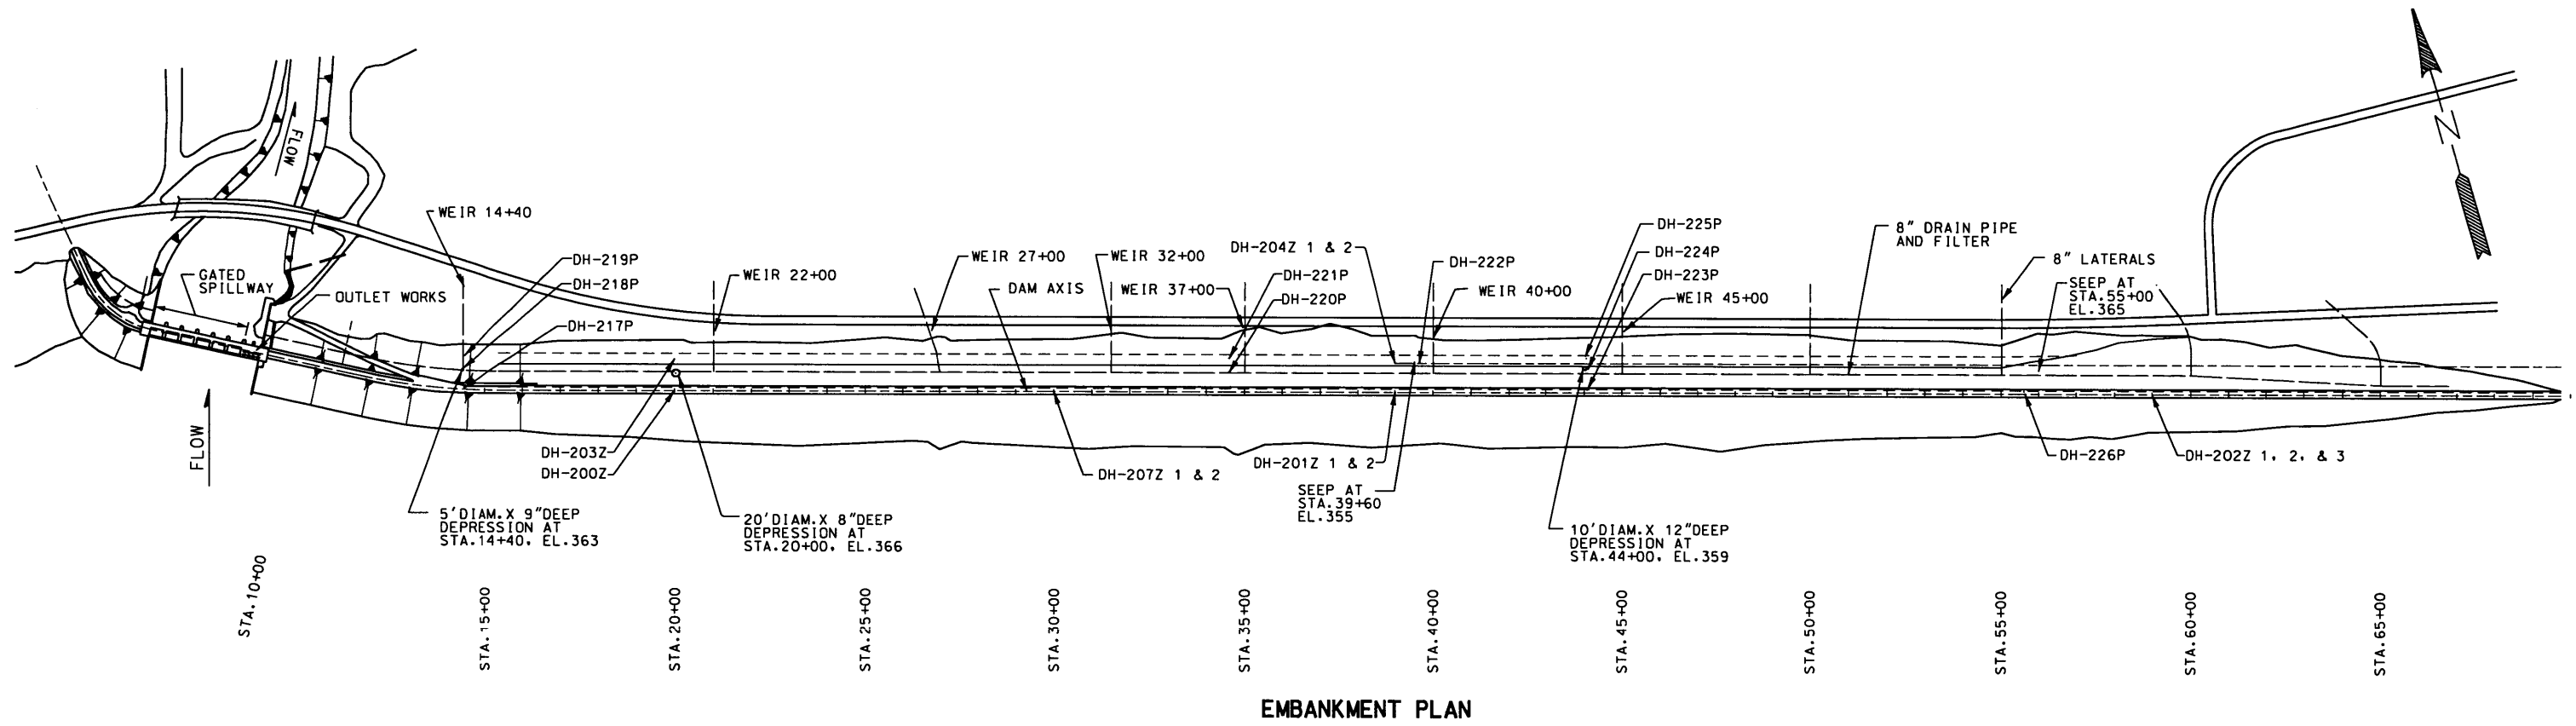
Figure 1.02-2 Plan View of Embankment

a. Results of Drilling and Soil Sampling. The ten drilling locations (DH-217 to DH-226) are shown on Figure 1.02-2. DH-218 and DH-224 were located in the depressions at stations 14+40 and 44+00. DH-222 was located at station 39+60 where

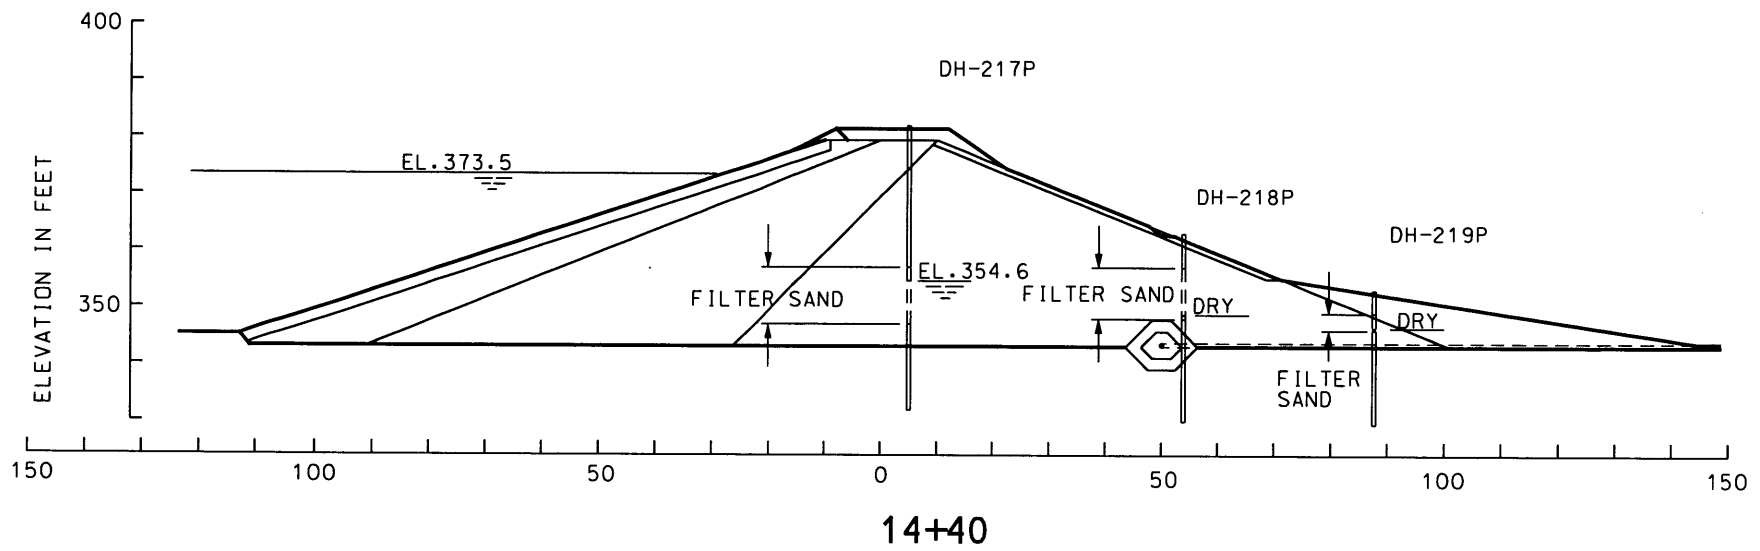
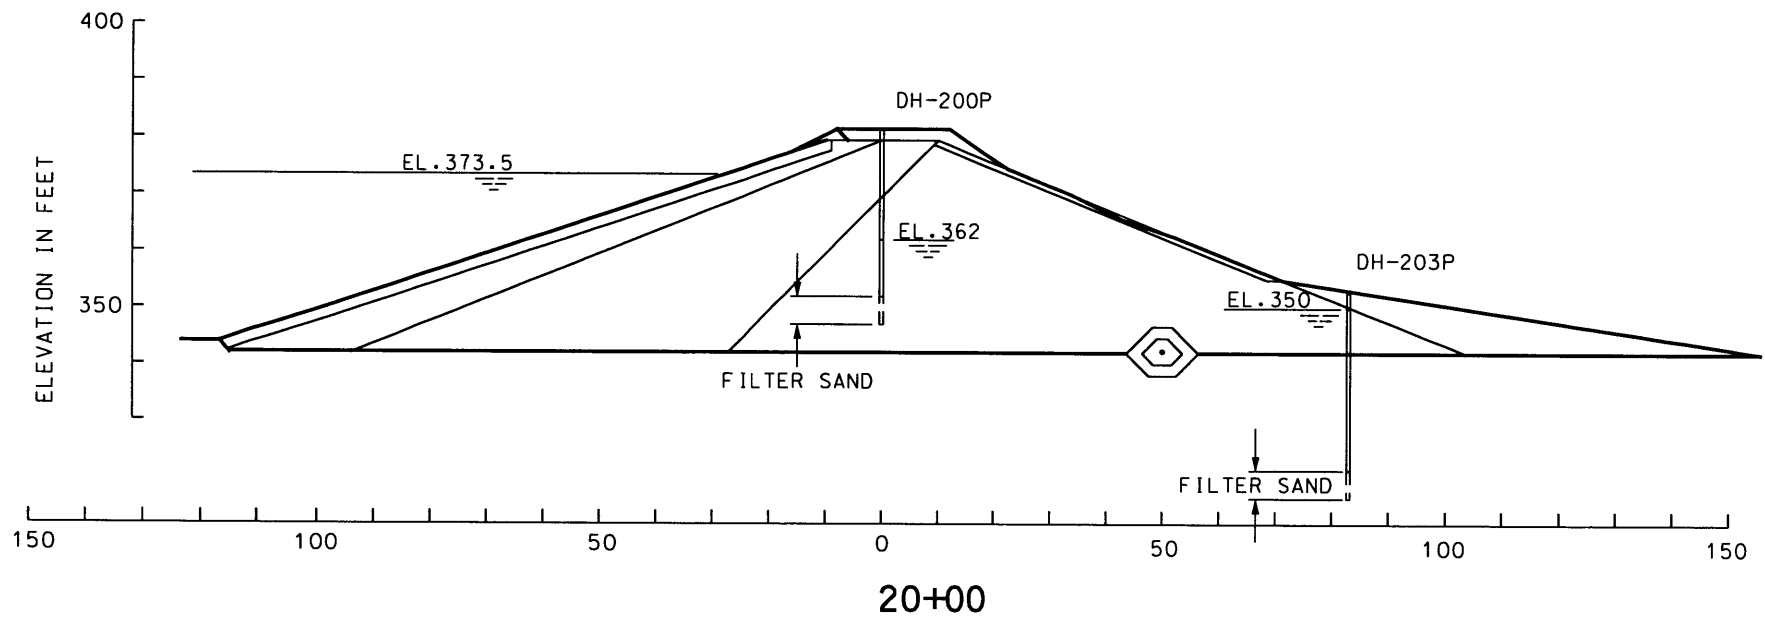
Figure 4.03-1. Summer 2003 Piezometric Levels at Stations 14+40 and 20+00

4.03. Summer 2003 Piezometric Water Levels. Figures 4.03-1 through 4.03-5 show Summer 2003 water levels measured in the 11 piezometers installed in 1980 and the 10 piezometers installed in June 2003.

The summer piezometric water levels are generally reasonable for seepage through the dam from the reservoir. No seepage is emerging from the downstream slope.

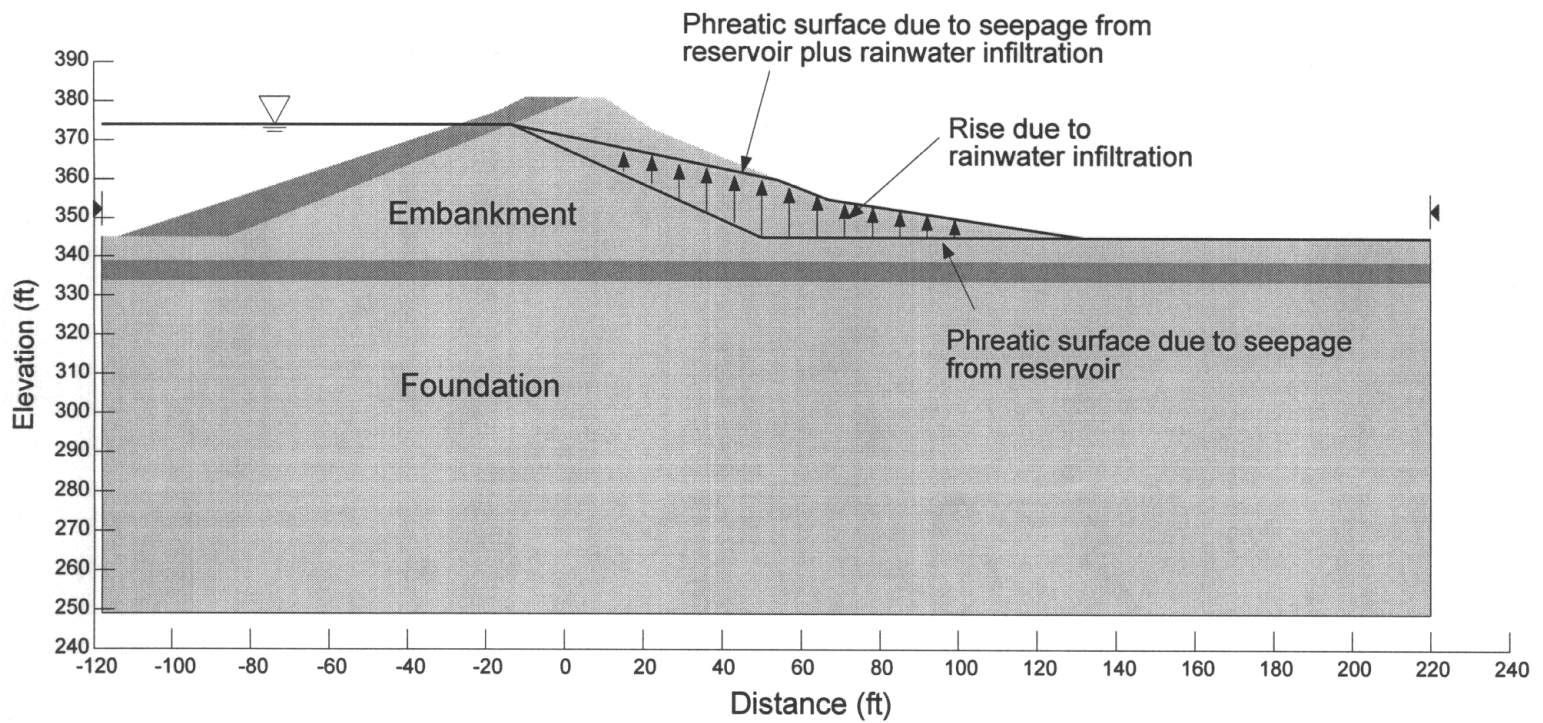
Figure 5-1. Influence of rainwater infiltration assumed in preliminary stability analysis.

The critical reservoir elevation of 371 ft is based on a preliminary stability analysis with an assumed phreatic surface in the embankment during the rainy season. The phreatic surface in the embankment was assumed to be a straight line between the reservoir elevation and the highest observed elevation of seepage emerging from the downstream slope, 360 ft. This approximation assumes the phreatic surface due to seepage from the reservoir is added to by rainwater infiltration as shown in Figure 5-1. Figure 5-2 shows safe and unsafe phreatic surfaces with seepage emerging from the downstream slope at elevation 360 ft. The sprinkler tests described in section III, 3.02 will provide measurements of the phreatic surface caused by simulated rainfall infiltration. This measured phreatic surface will be used in the stability analysis included in the future letter report. Another measured output of the sprinkler tests will be the strength of the embankment softened by the simulated rainfall infiltration, which will also be included in the future stability analysis. This measured softened strength is expected to be higher than the current assumed embankment strength used in the preliminary stability
